# New York State Department of Transportation

## PIA Safety Flag NB23U4W019

**BIN: 1065318**

**Feature Carried: 278I278IX2M23027**

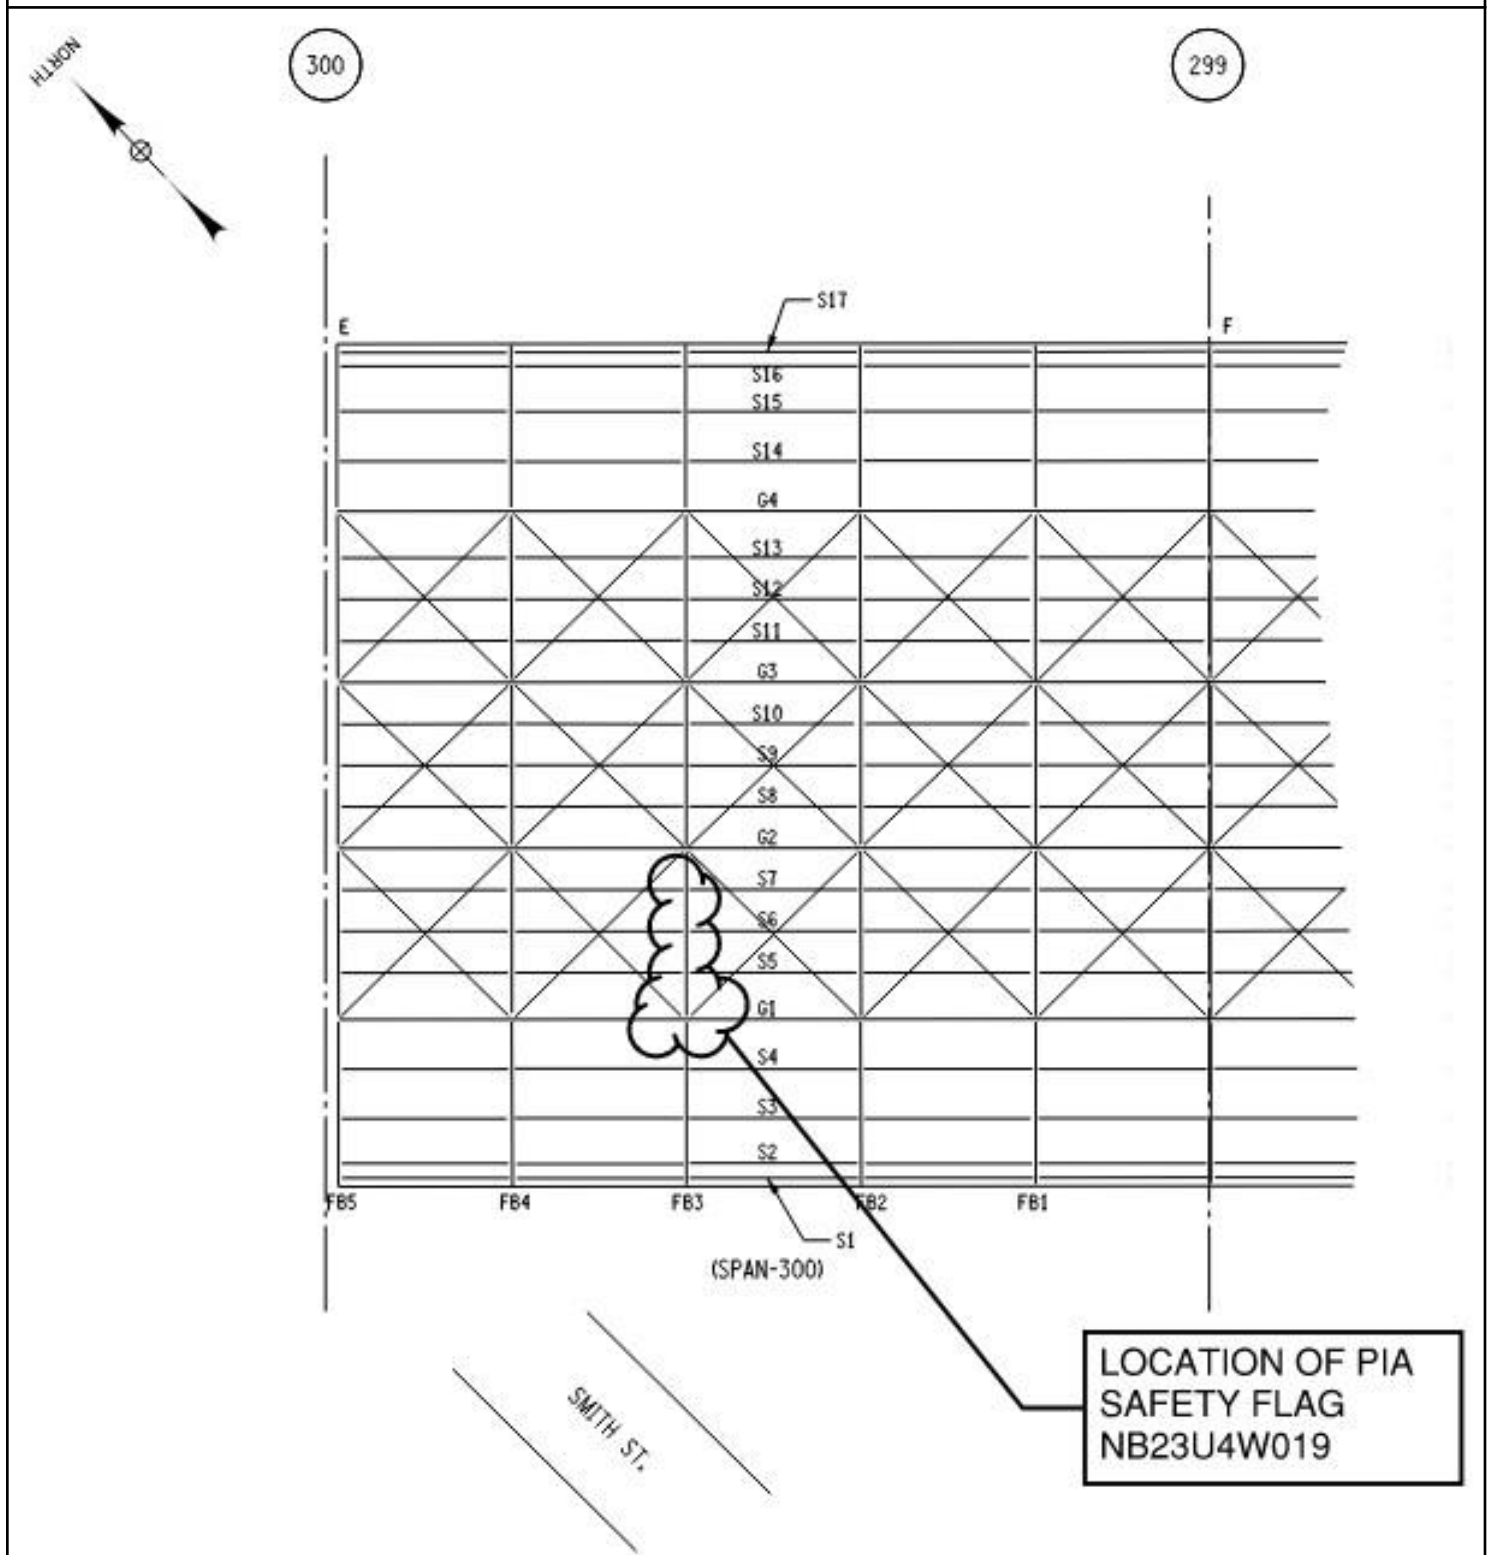
Photo Number: 1

Location: Span 300, Girder G1 and Floorbeam FB3 between G1 and G2.

This flag is located at an elevation of more than 120 feet over Hamilton Avenue WB, between the Gowanus Canal and Smith Street.

**Attachment Description: Flag Location Plan**

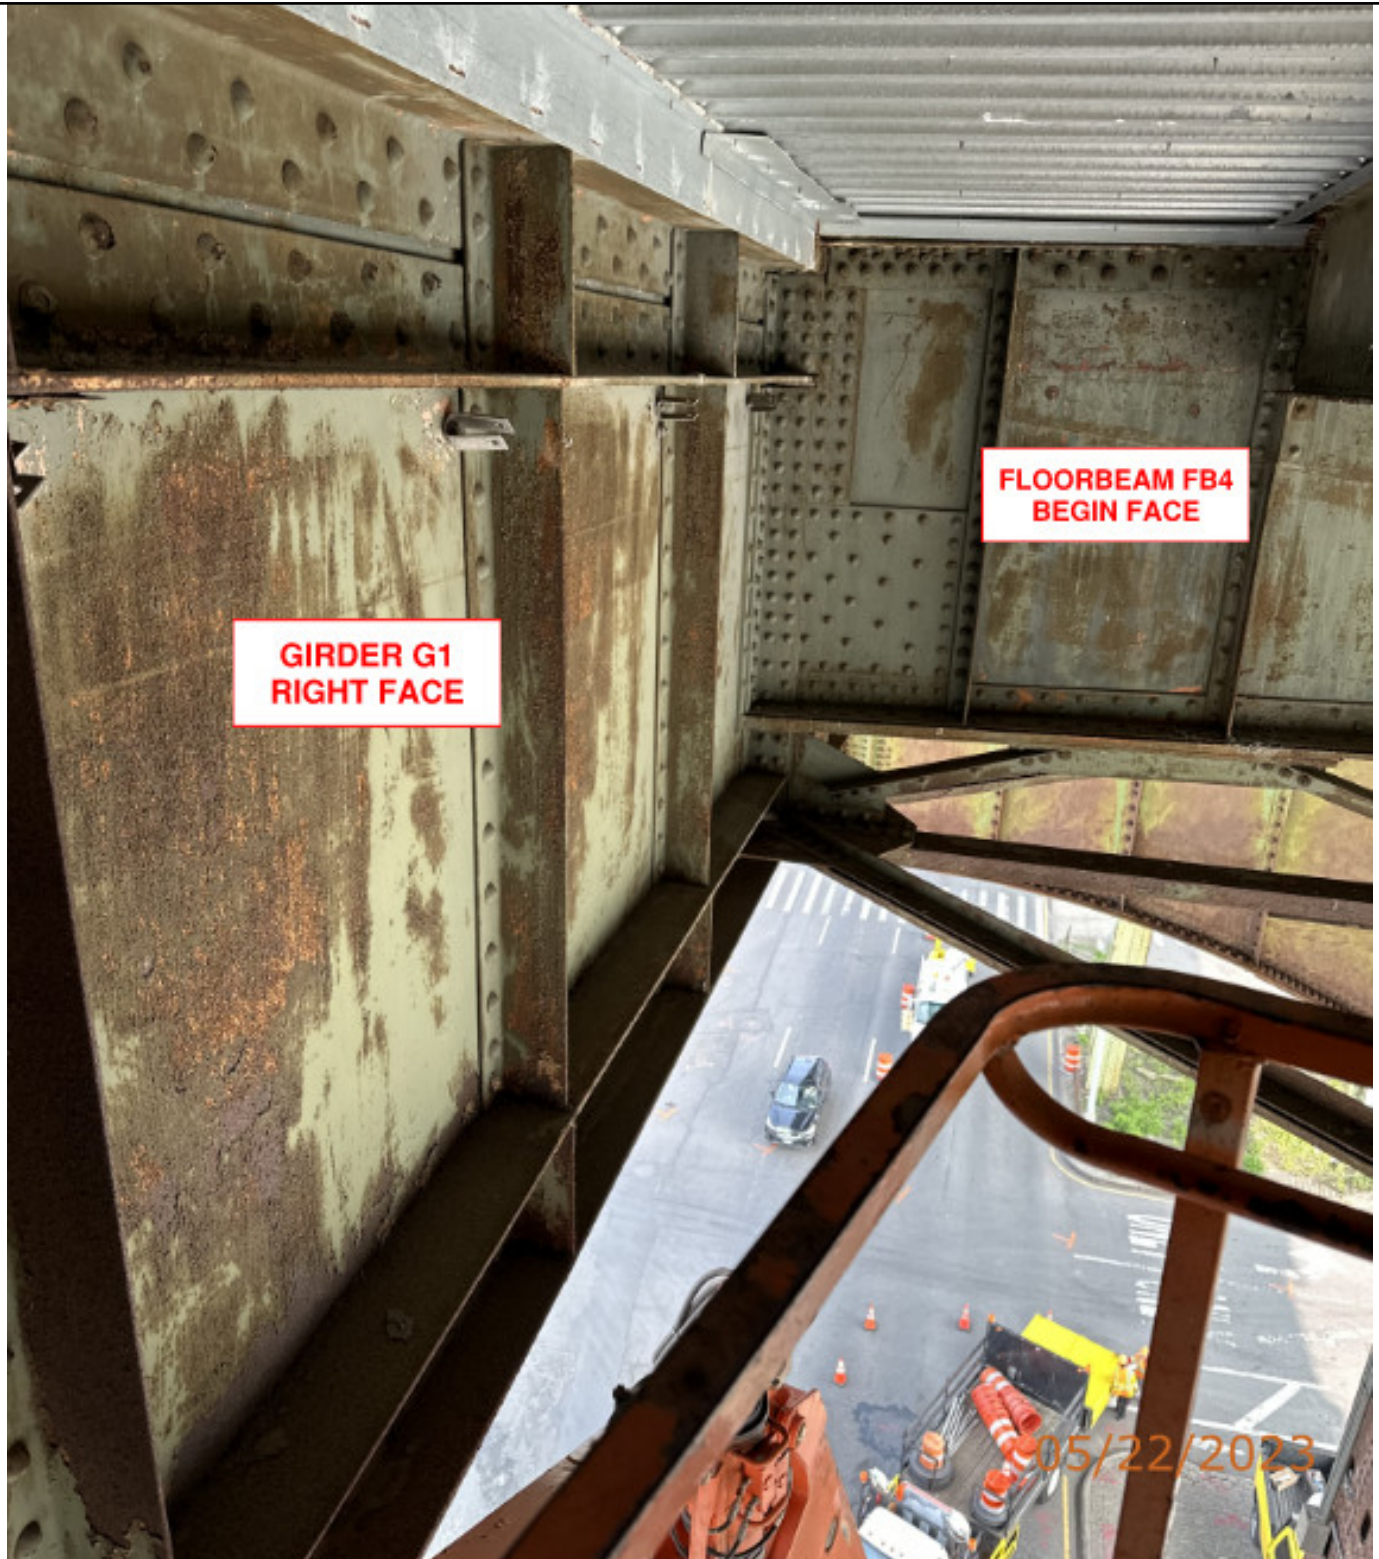
Photo Number: 2

**Attachment Description:** General View of the roadway below the girder and floorbeam in Span 300. The PIA location is over similar. Looking End-Left.

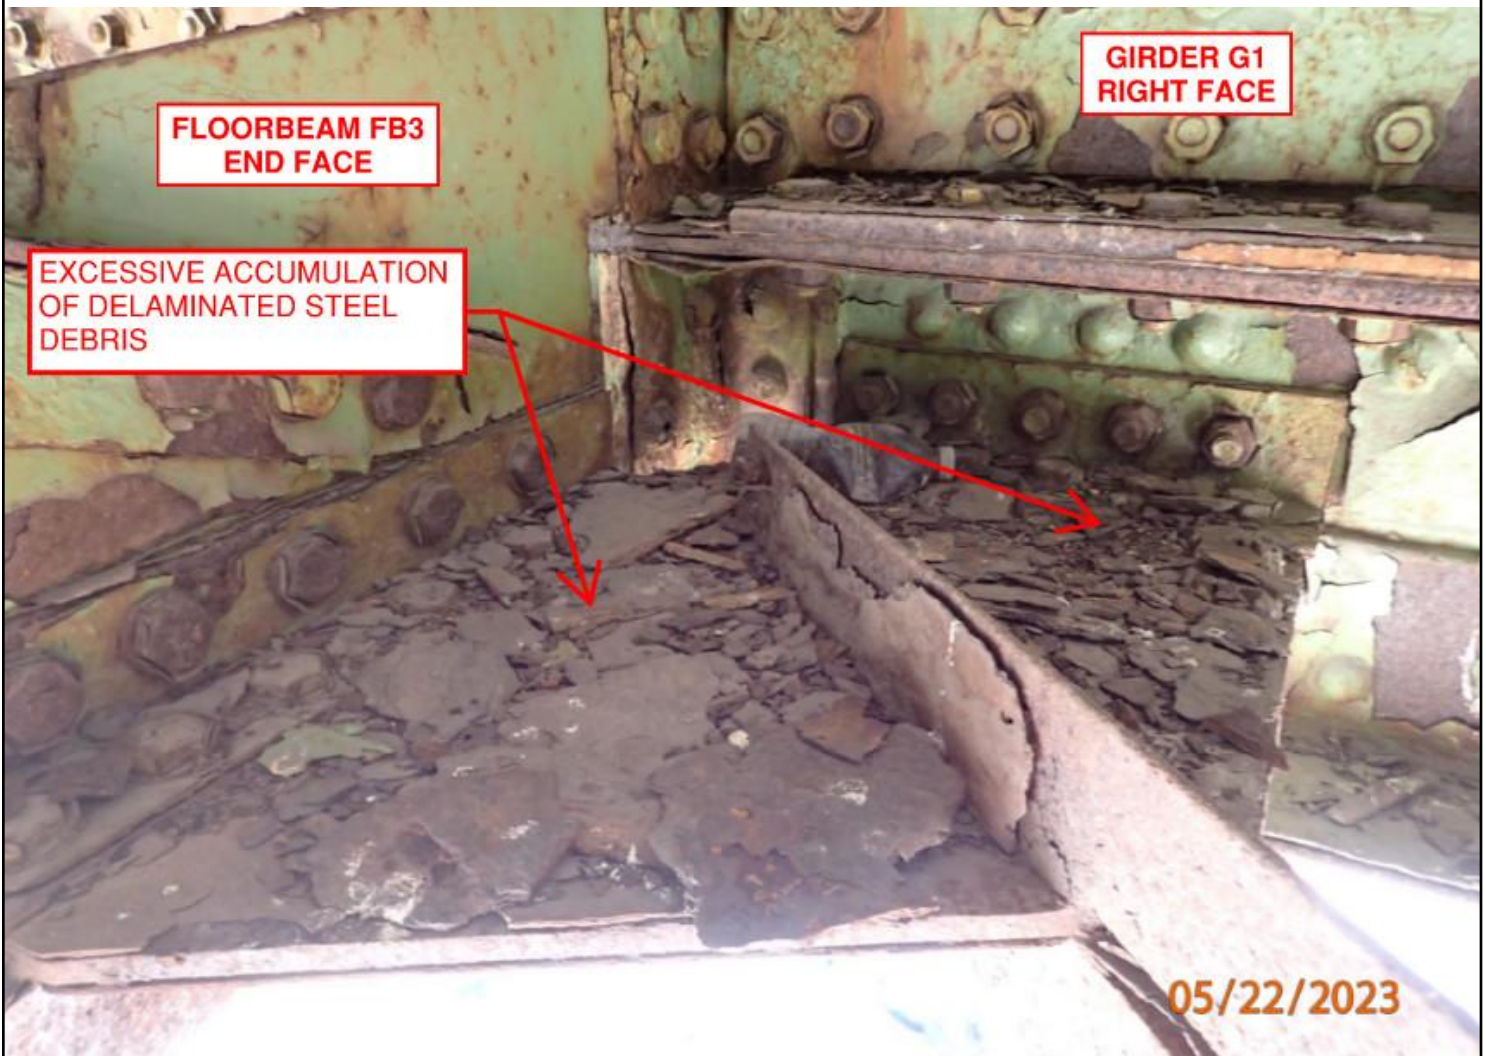
Photo Number: 3

The heavy debris from delaminated steel surfaces is accumulated in excessive amounts on the following structural elements and as such is prone to fall onto vehicular traffic below:

- (1) Lower top flange and both (upper and lower) bottom flanges of the Girder G1 on the right face at Floorbeam FB3,
- (2) Floorbeam FB3 bottom flange on both sides of the FB web, between Girders G1 and G2, and
- (3) The diagonal and horizontal chord members in the vertical truss assembly below Floorbeam FB3, between Girders G1 and G2.

**Attachment Description:** Excessive accumulation of steel debris on the horizontal gusset plate at Floorbeam FB3 End Face and Girder G1 Right Face. Looking Begin-Left.

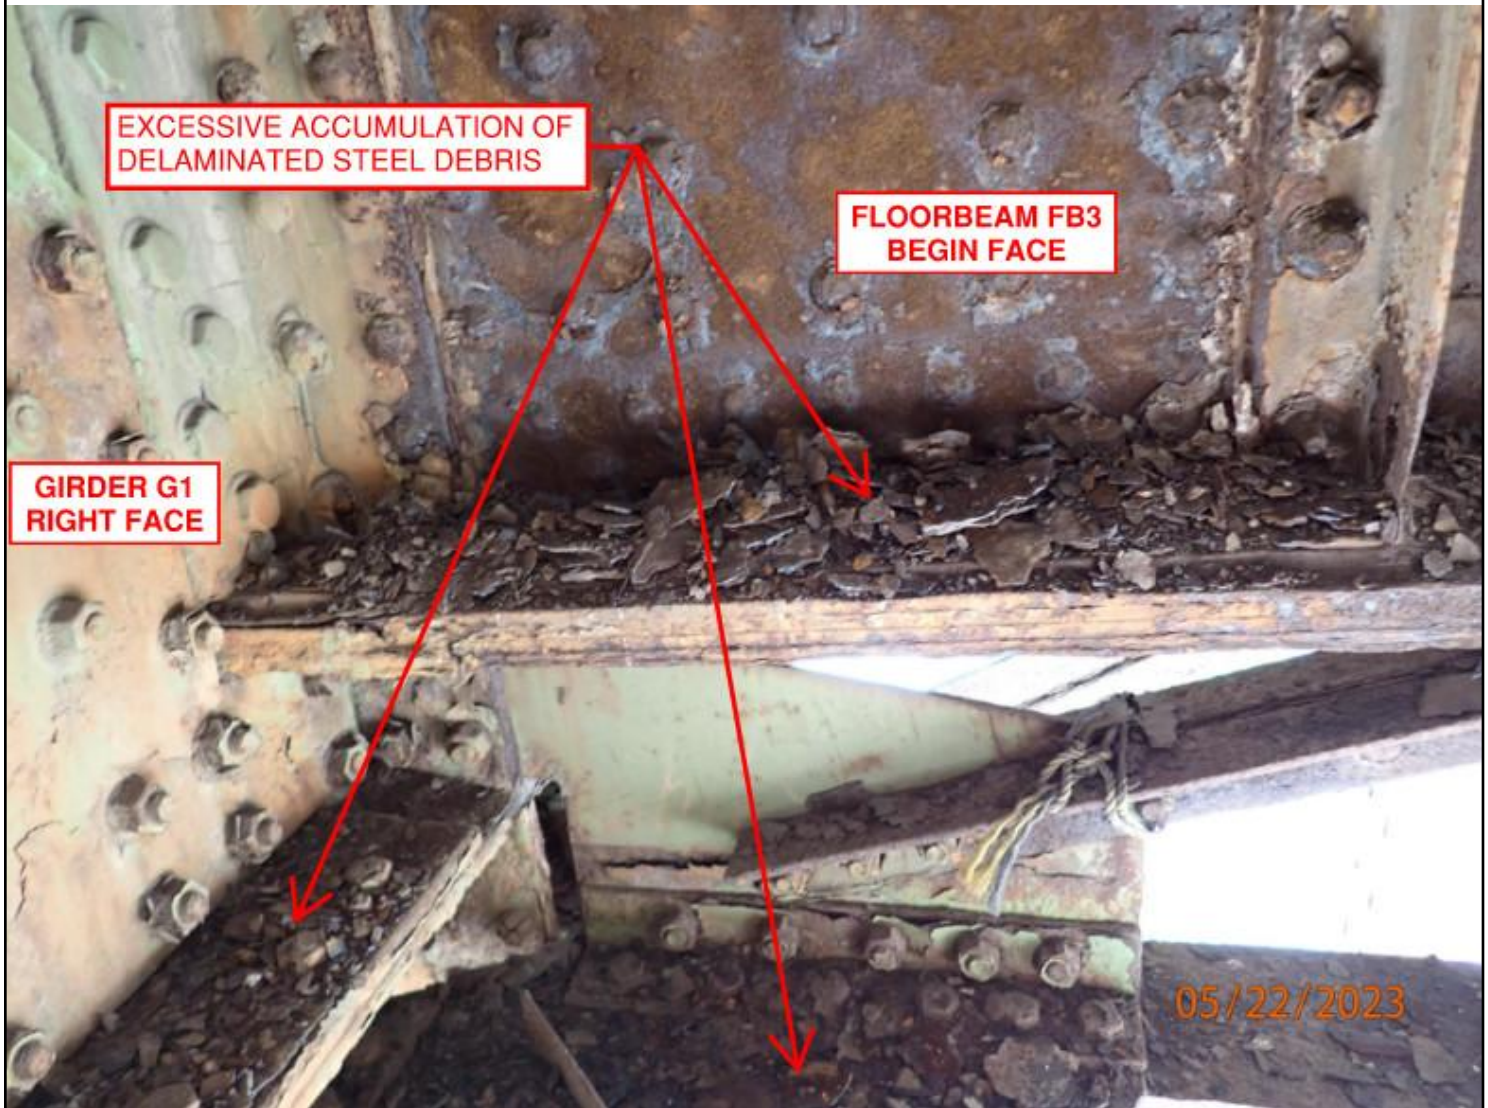
Photo Number: 4

**Attachment Description:** Excessive accumulation of steel debris on the horizontal gusset plate and bottom flanges of Floorbeam FB3 on the Begin Face and Girder G1 Right Face. Looking End-Left.

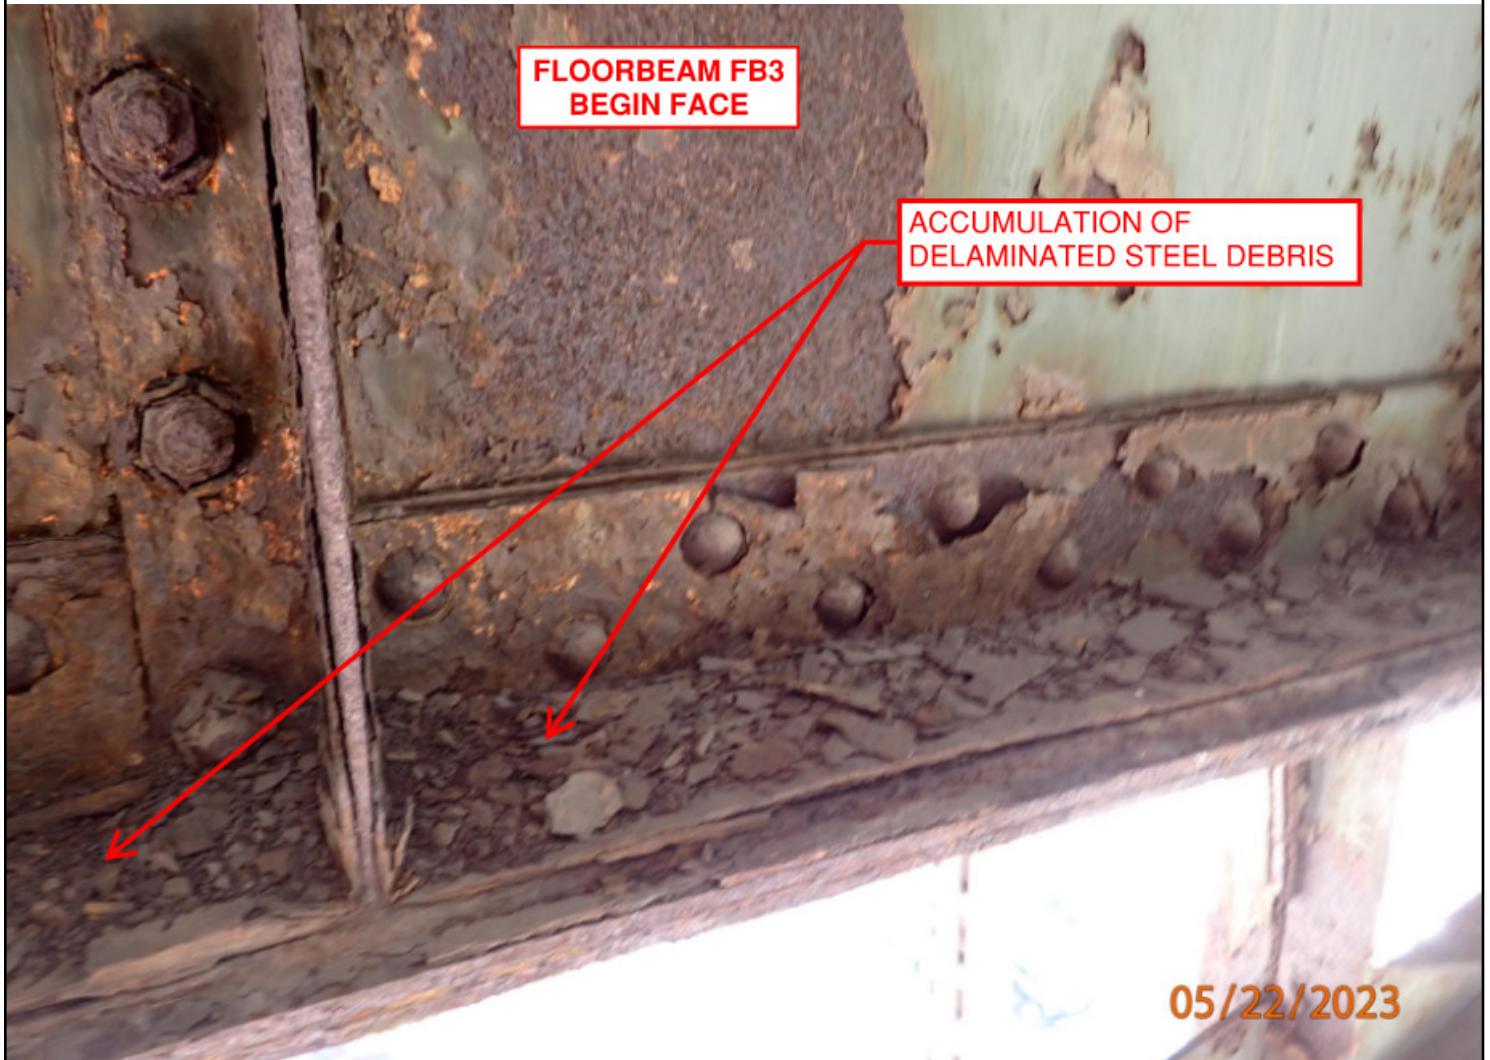
Photo Number: 5

**Attachment Description:** Accumulation of steel debris on bottom flange of Floorbeam FB3 on Begin Face. Looking End-Right.

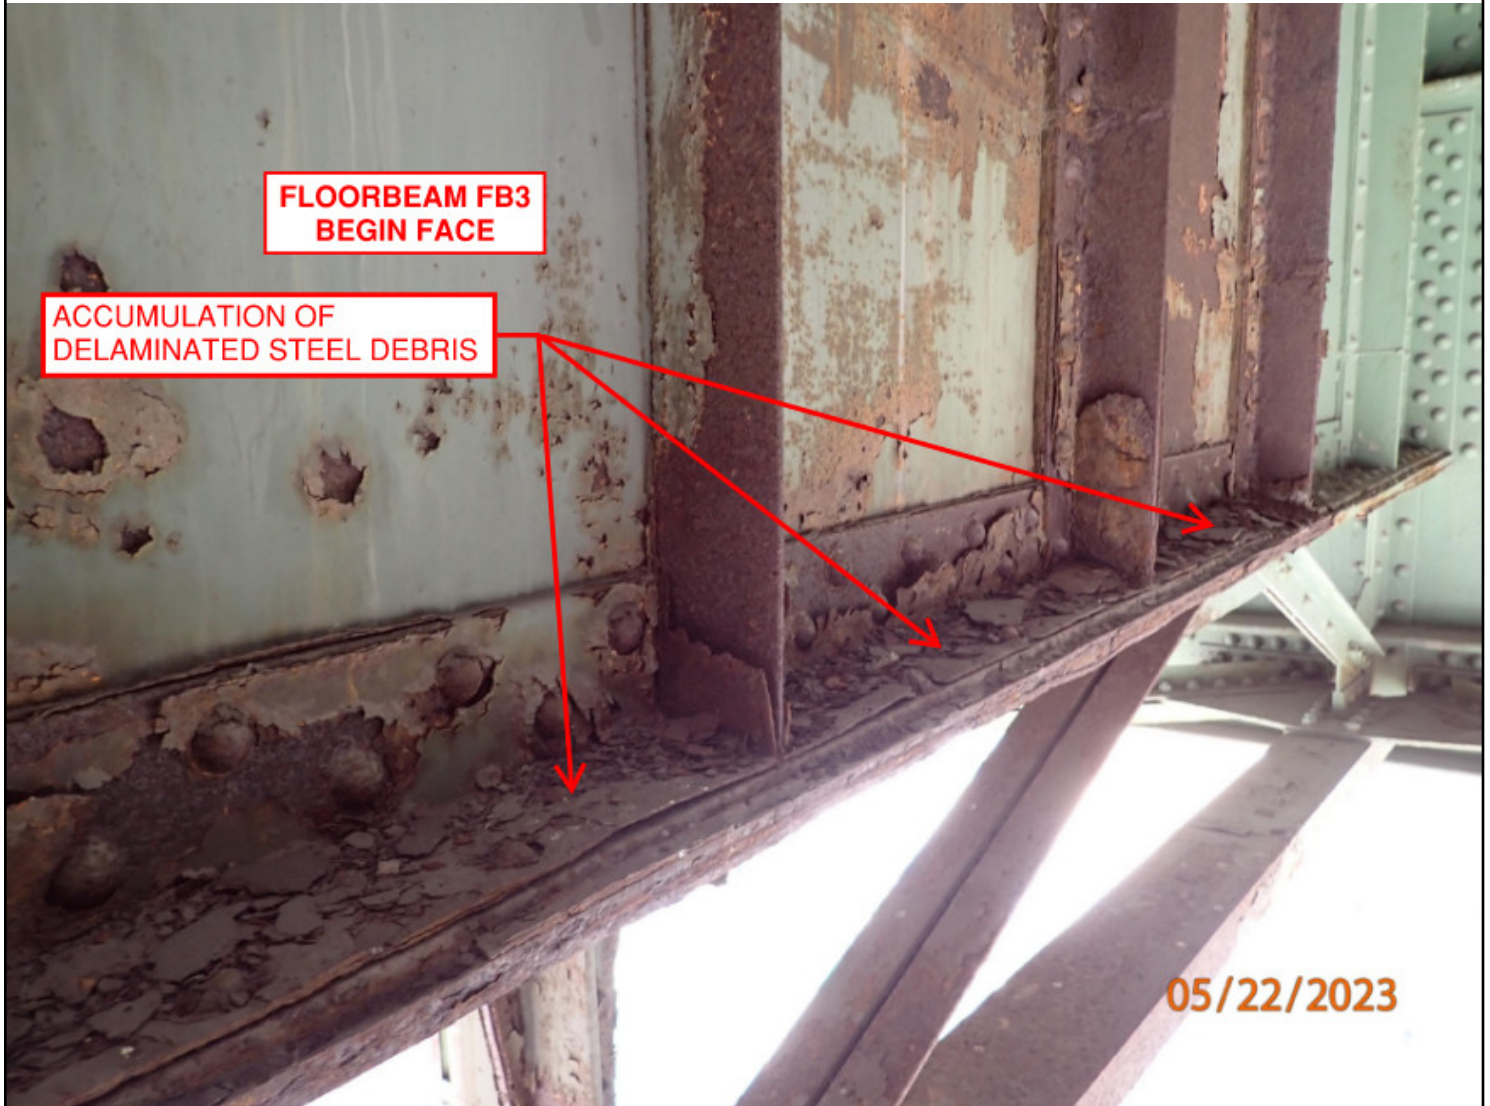
Photo Number: 6

**Attachment Description:** Accumulation of steel debris on bottom flange of Floorbeam FB3 on the Begin Face. Looking End-Right.
